97V-131 (01)

**RE: Recall Campaign -- Cruise Control and Throttle Cables
1992-97 BMW 3-Carline, 1989-95 BMW 5-Carline,
1993-97 BMW 740i, 740iL, 1994-97 BMW 840Ci**

Group 35 Pedals	Bulletin Number 35 01 97 Page 1 of 6	Woodcliff Lake, NJ October 1997 Product Engineering
--------------------	--------------------------------------------	-----------------------------------------------------------

SUBJECT: Recall Campaign 97V-131

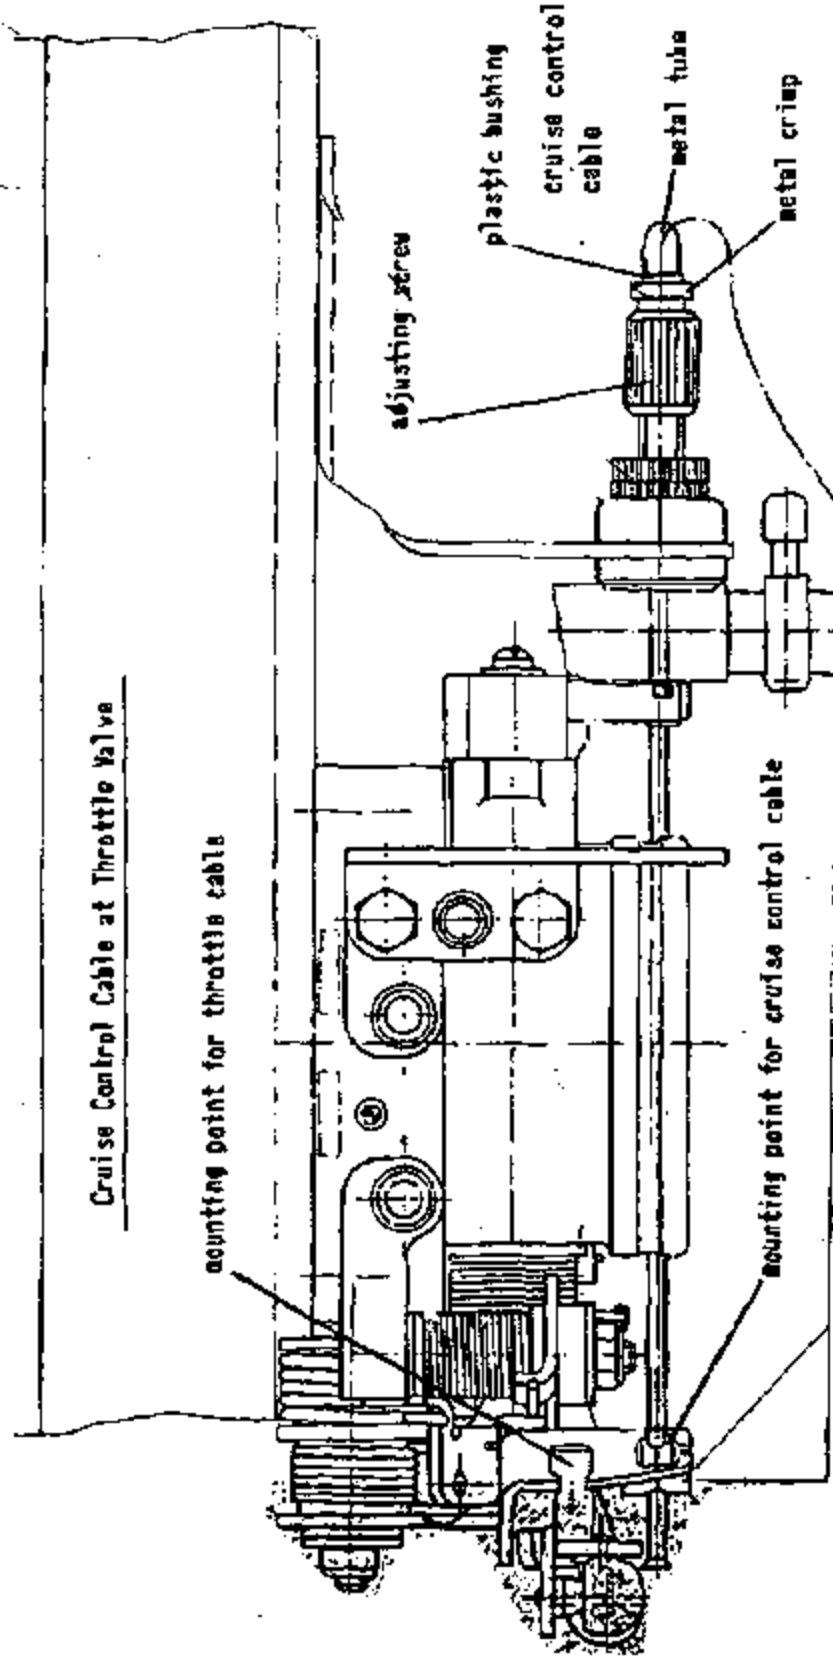
Cruise Control Cable at Throttle Valve

3. The number of vehicles potentially containing the defect is approximately 410,000.
4. The percentage of vehicles estimated to actually contain the defect is less than 1%.
5. The potential defect involves the cruise control and throttle cables of the subject vehicles. Both Bowden cables are attached to the same throttle valve actuating lever at the throttle housing. See attached drawing. It is possible that the plastic bushing on either cable, at the adjusting screw near the throttle housing, could break due to environmental influences coupled with vibration. If this were to occur, the metal outer tube of the cable assembly could become moveable in the bushing.

While it is extremely unlikely that the outer tube of the throttle cable, due to spring forces in that system, could be dislodged from the bushing during operation of the throttle linkage, it is possible that the outer tube of the cruise control cable could do so.

In this case, during application of the throttle pedal without cruise control being engaged, the throttle cable would be under tension while the cruise control would be slack and could dislodge from the bushing. During subsequent release of the pedal, with simultaneous tensioning of the cruise control cable, the outer tube could catch on the edge of the broken bushing, rather than reentering the bushing. This would cause the throttle valve to remain partially open. If this were to occur, a higher-than-normal idle speed would be present in the transmission's Neutral position and the vehicle might not decelerate as expected when the throttle pedal is released.

7. Not applicable
8. BMW will conduct a recall campaign to remedy the defect in the affected vehicles. The remedy will consist of installing a spring steel clip on the outer tube of each cable in the area of the adjusting screw and plastic bushing. The clip will prevent the outer tube from dislodging from the bushing. The clips were implemented in production beginning in early August 1997.

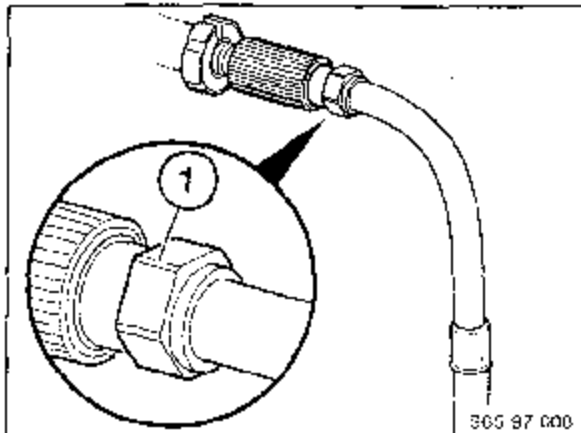
90° curved version cable
(1) Metal Ring

If a cable has the metal ring as illustrated above, install the proper spring steel clip as illustrated below.

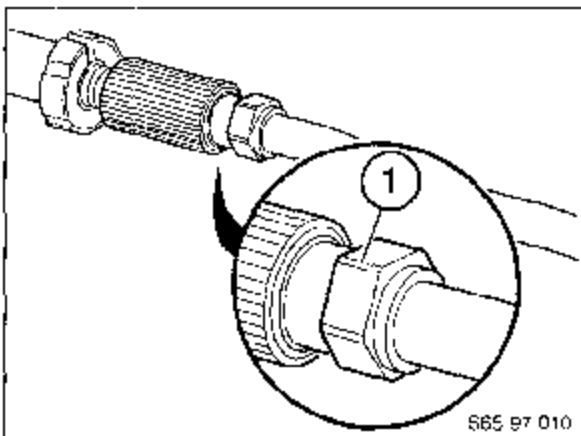
Straight version cable
(1) Metal Ring
