Safety Defect and Noncompliance Report Guide for Vehicles
PART 573 Defect and Noncompliance Responsibility and Reports¹

Wheel end studs improperly tempered, potentially rendering them brittle and susceptible to fracture.

Neville Welding Inc. has determined that a defect which relates to motor vehicle safety exists in certain wheel end studs shipped by our supplier. ArvinMeritor assembled these wheel end studs into hubs, which were then subsequently assembled into axles. These axles were assembled into dropdeck, grain hopper and flatbed trailers and sold to aftermarket customers between April 18, 2008 and June 4, 2008.

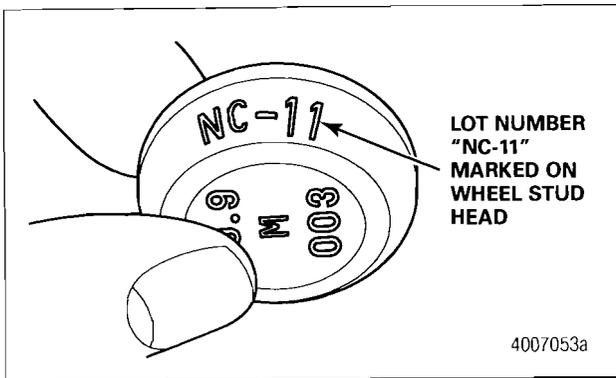
Figure 4

Remove the Wheel Studs from a Hub Mounted on the Axle

1. Wear safe eye protection.
2. Park the vehicle on a level surface. Block the wheels to prevent the vehicle from moving.
3. Raise the axle of the wheels to be serviced. Support the vehicle with safety stands.
4. For drum brake applications, back off the brake at the slack adjuster until the brake shoes retract and the drum clears the linings. Figure 5. The wheel studs on disc brake applications with the suspect wheel stud should be serviceable without adjusting the brakes or loosening the rotor.

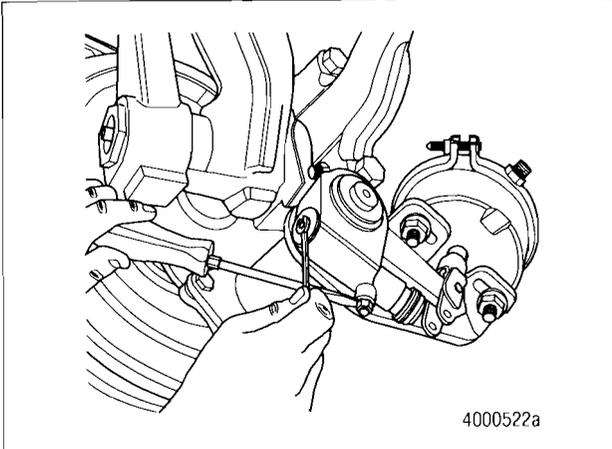
Figure 5

5. Remove the brake drum if applicable.

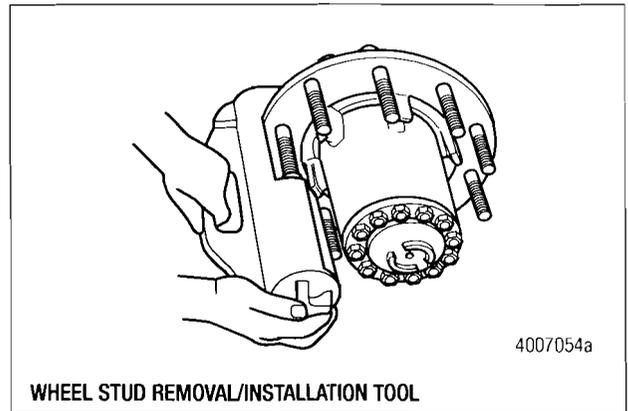
6. Use a wheel stud removal/installation tool, modified C-clamp or other appropriate tool to remove the wheel studs. Support the back face of the hub while you press on the outboard end of the wheel stud. Ensure the tool is aligned with the wheel stud, so the wheel stud pushes straight out. Refer to the tool manufacturer's instructions for correct operating procedures. Figure 6 and Figure 7.

WHEEL STUD REMOVAL/INSTALLATION TOOL

4. Use a wheel stud removal/installation tool or a modified C-clamp to install the wheel stud into the hub wheel stud hole. Ensure the hub flange is fully supported, so no loads are transmitted to the bearings or seals. Verify the tool is aligned with the wheel stud, so the wheel stud pushes straight in. Figure 6 and Figure 7.
5. Verify the wheel stud is fully seated against the hub flange. Use a 0.002-inch feeler gauge to check the gap between the wheel stud and the hub flange. If the feeler gauge fits under the wheel stud head, reseal the wheel stud. Figure 9.

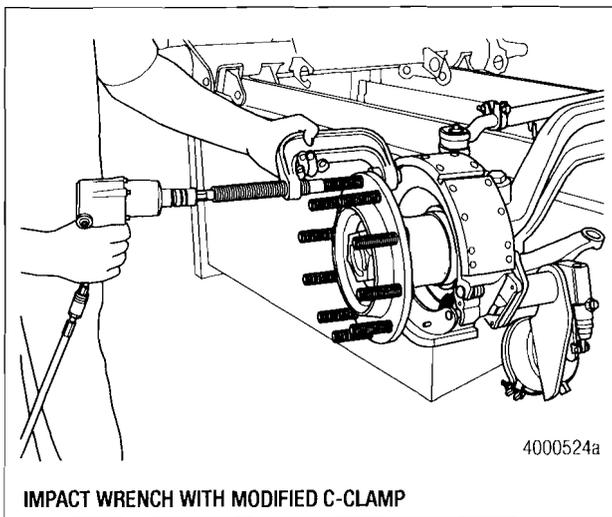
Figure 7

IMPACT WRENCH WITH MODIFIED C-CLAMP

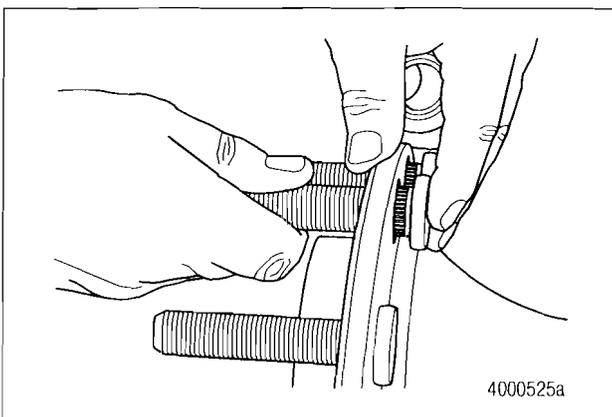
Figure 8

1. Inspect the wheel stud holes for any damage that may affect the press fit between the hub and the new wheel stud. A ribbed pattern in the wheel stud hole resulting from the serrations on the original wheel stud is normal. Ensure there are no burrs present and that the hole is round and untapered.
 - **If burrs are present:** Remove them with a file.
 - **If the hole is out of round or tapered:** Replace the hub.
2. Thoroughly clean the wheel stud hole and flange surface of any debris.
3. Insert a new wheel stud into the hub wheel stud hole. Align the wheel stud serrations on the new wheel stud with the serration marks in the hub wheel stud hole. Figure 8.

3. Use a crocus cloth to clean all the flat surfaces on the wheel and hub.
4. Insert a new wheel stud into the hub wheel stud hole. Align the wheel stud serrations on the new wheel stud with the serration marks in the hub wheel stud hole. Figure 8.
